The CB&Q Depot at Washington, Iowa

Nelson P. Moyer

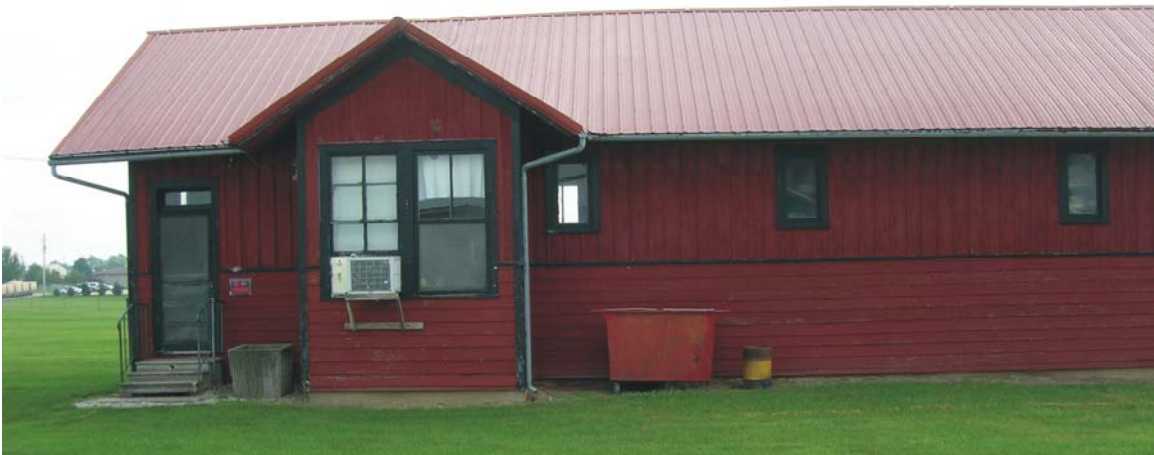
Left front view of depot after move to the fairgrounds.

The depot was moved to the Washington County fairgrounds in November 1973. The chimney was removed prior to the move, and the depot was placed on a cinder block foundation at the fairgrounds. A metal roof was installed to replace shingles.

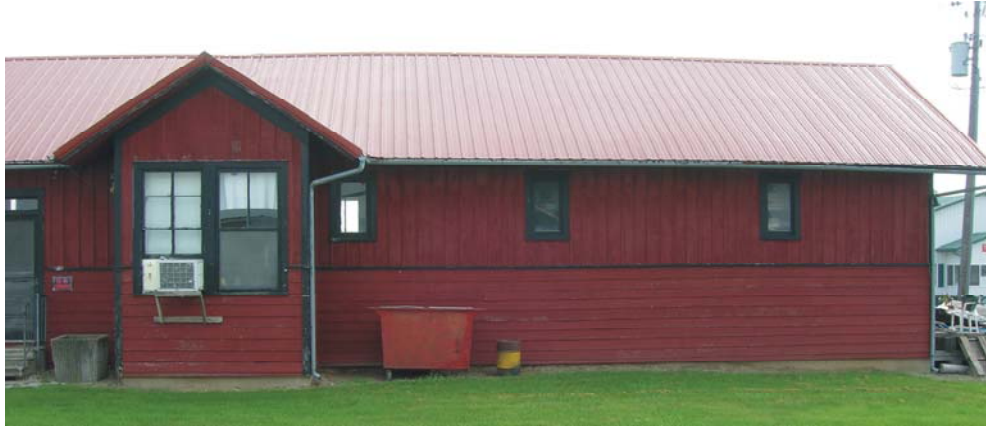
Right front view of depot after move to the fairgrounds.

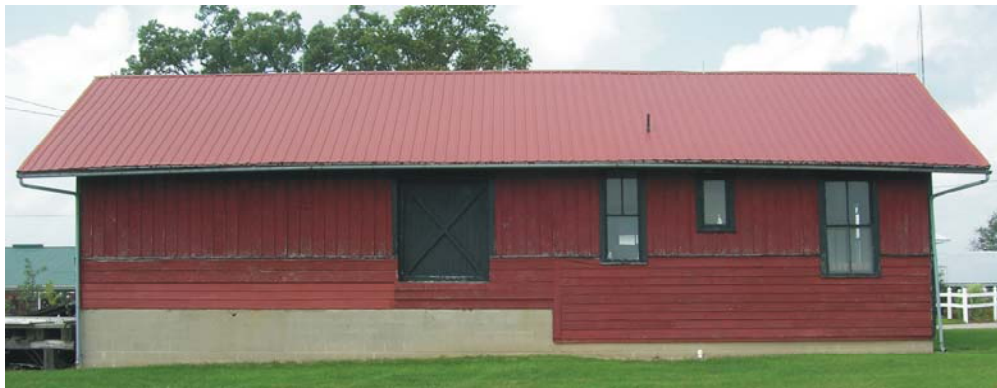
Rear view of depot after move to fairgrounds.

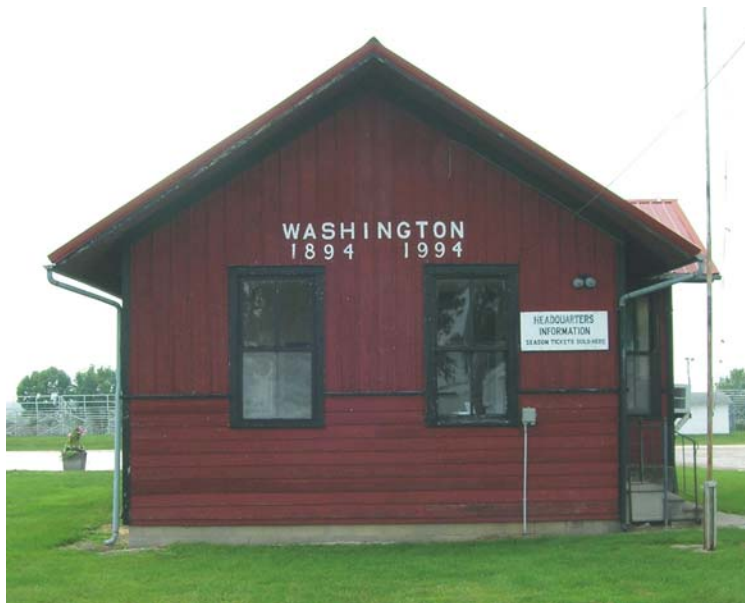
Waiting room end view of depot after move to fairgrounds.

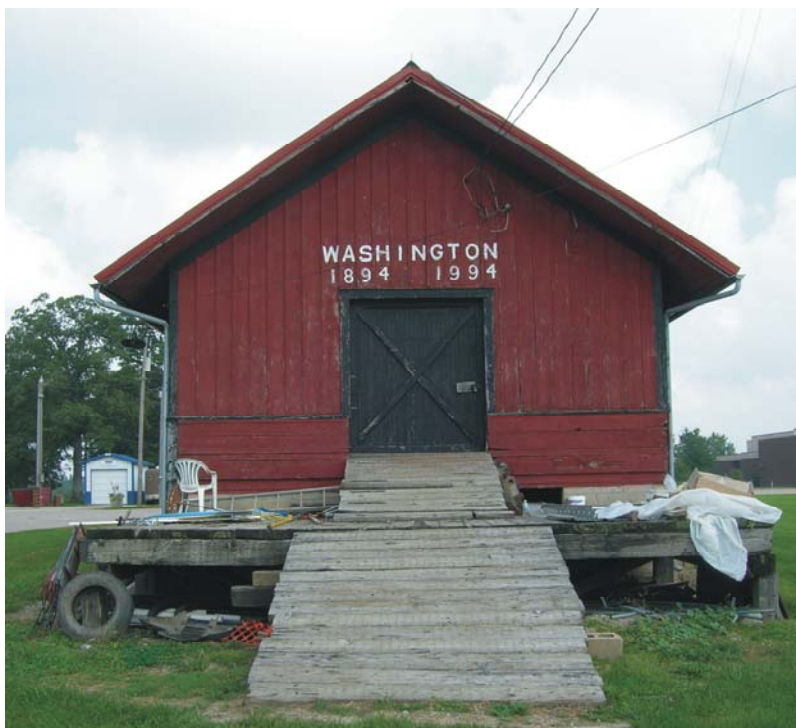
Freight room end view after move to fairgrounds.
