What if the Chicago Great Western Had NE-6 Caboosees?

By Tony J. Bowen

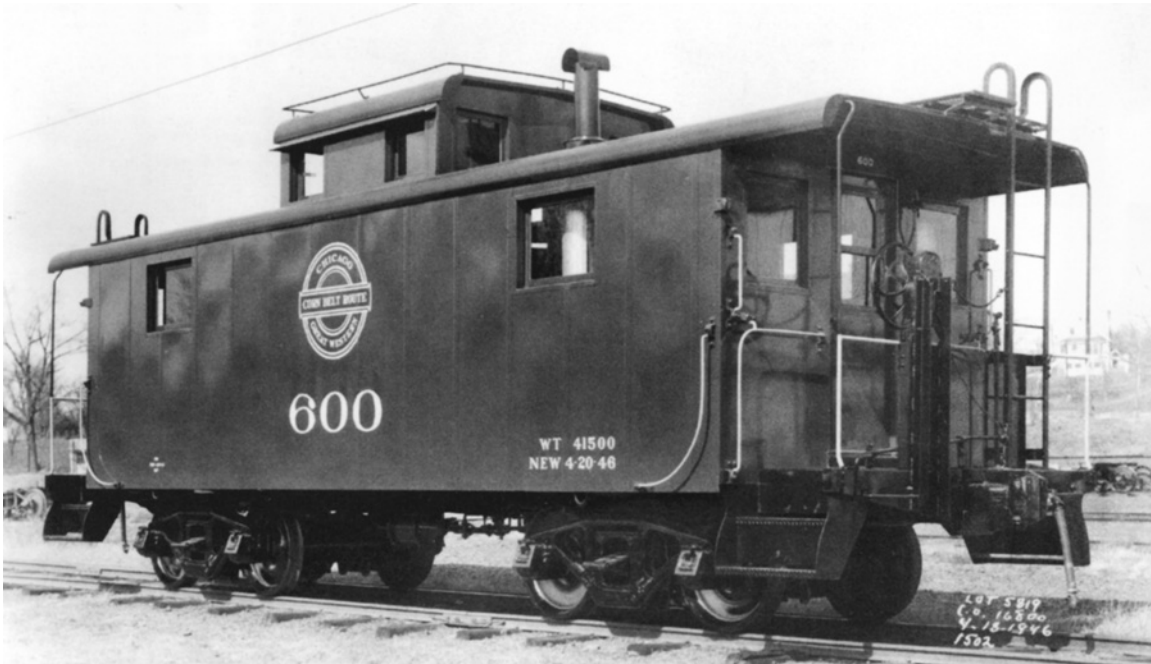
April 18, 1946 outside Pullman-Standard's Worcester, Massachusetts's plant. This exterior photo shows the original paint with an open window next to the coal stove. In time the window would be taken out and replaced with a weld plate of steel going over the opening. (Photo from the IRM Archives)

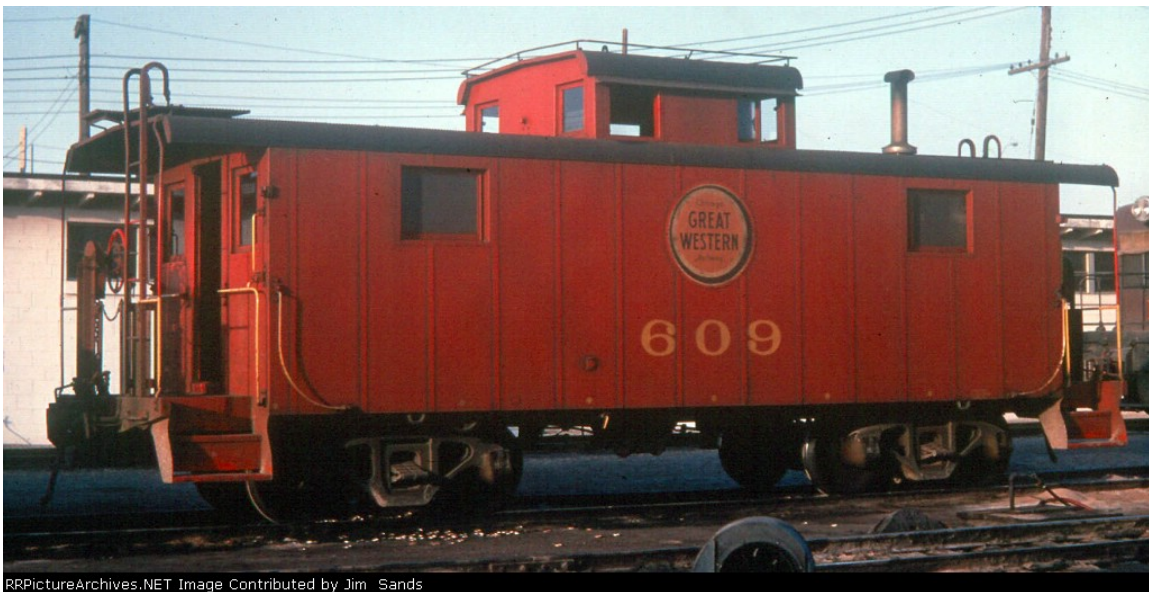
RRPictureArchives.NET Image Contributed by Jim Sands

CGW Caboose #609 painted in the bright red awaits its next assignment in Kansas City. The caboose continues to wear the CGW paint scheme even after the July 1, 1968 merger with the Chicago & Northwestern when this photograph was taken in 1970. (Photo used with permission from rrpicturearchives.net and Jim Sands)

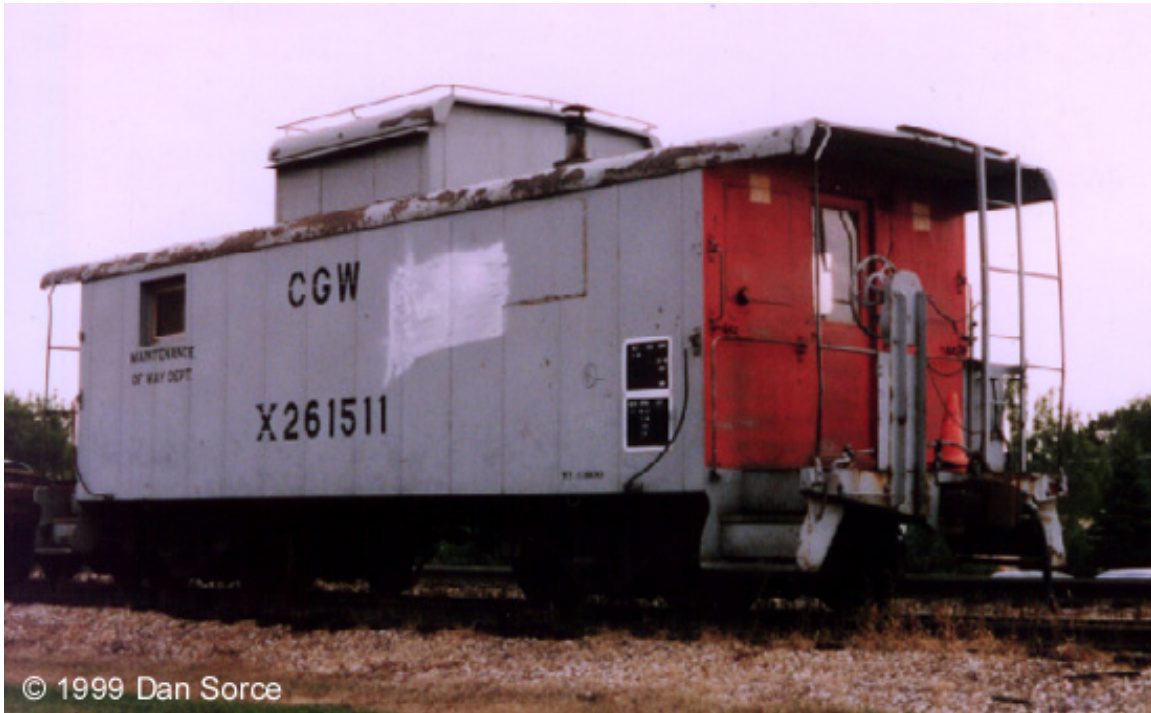
In 1999 we see a CGW heritage caboose, which was put into M.O.W. service by the Chicago & Northwestern. The CNW herald has been painted out as the caboose is now under the ownership of the Union Pacific. However, through it all the caboose managed to keep its CGW reporting marks. Note the welded steel plates over the cupola windows and the end windows on either side of the door. (Photo from Dan Sorce collection)

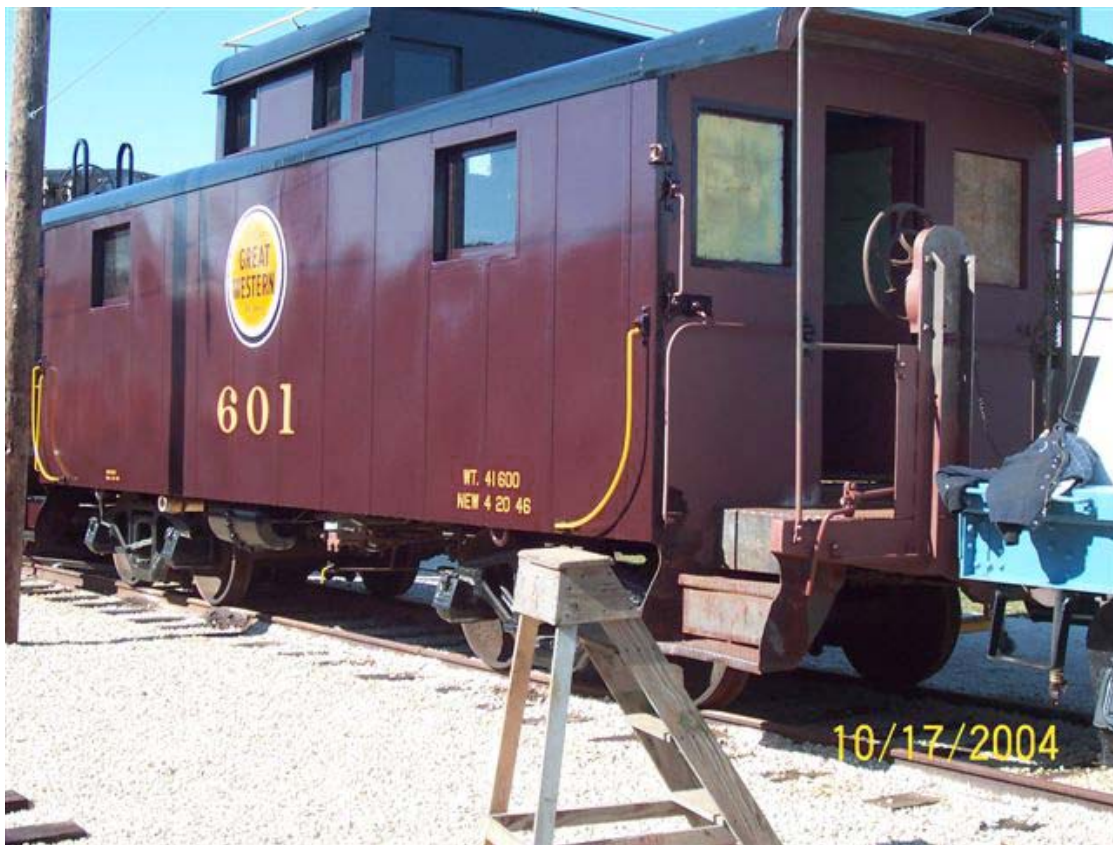
In October 2004 restoration work is well underway on CGW #601 at the Illinois Railway Museum in Union, IL. Progress continues towards restoring this caboose to its original appearance. (Photo from Illinois Railway Museum volunteer Rich Witt)
